Comments on engine survey report file number JS6686, Vessel Altitude Adjustment II.

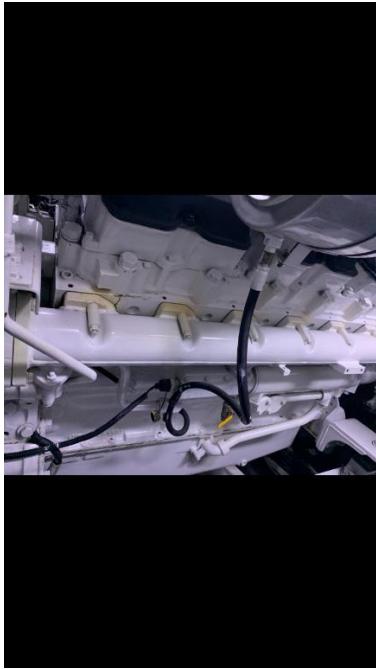
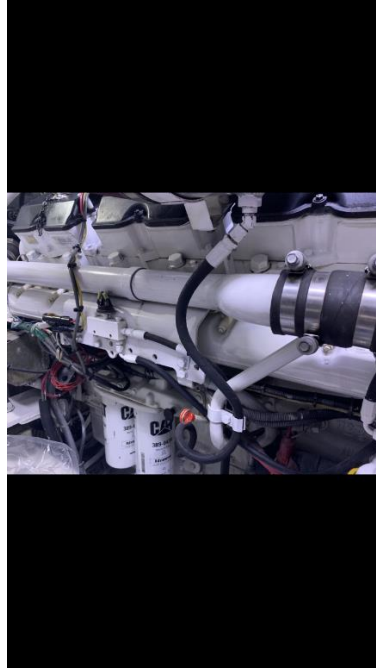
Engine pictures after sea trial and survey, show no to minimum oil leaks. (Ref. Remark 2)

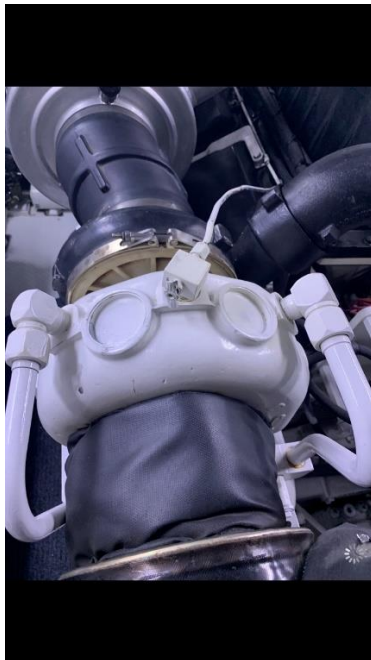
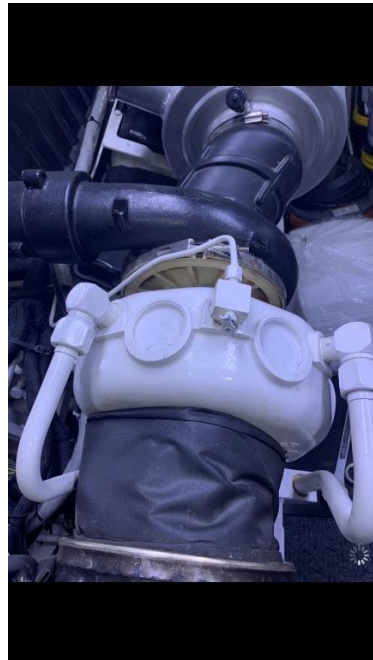
No signs of exhaust leak only minor heat discoloration. (Ref. Remark 8)

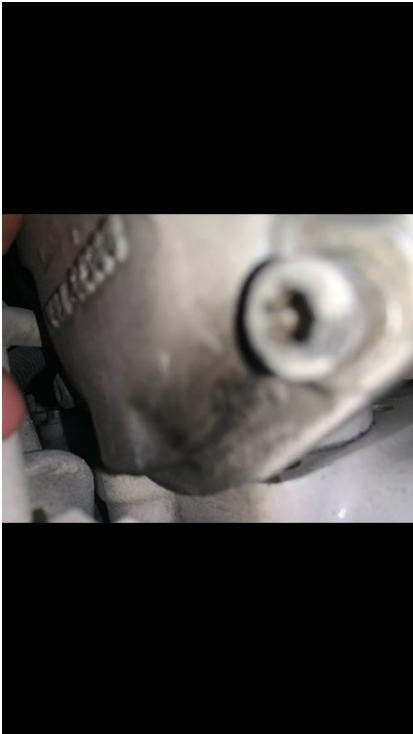
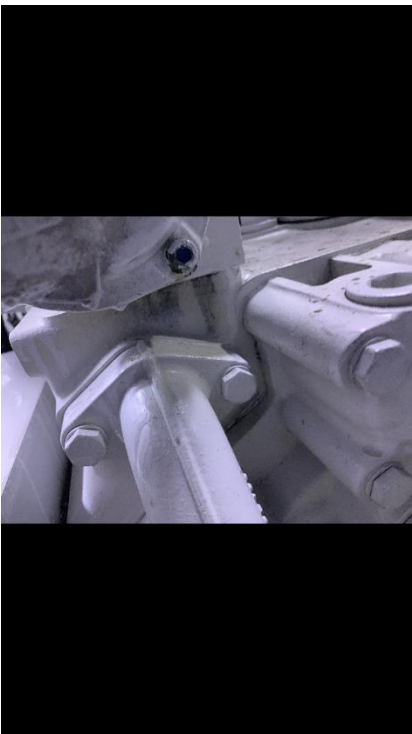
Transmission oil cooler no water leak (Ref. Remark 9)

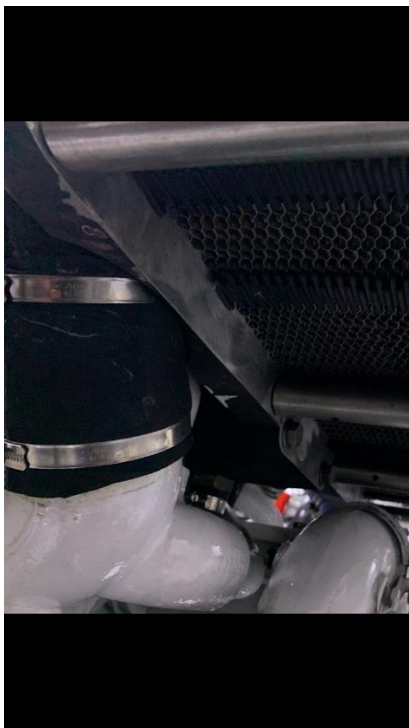
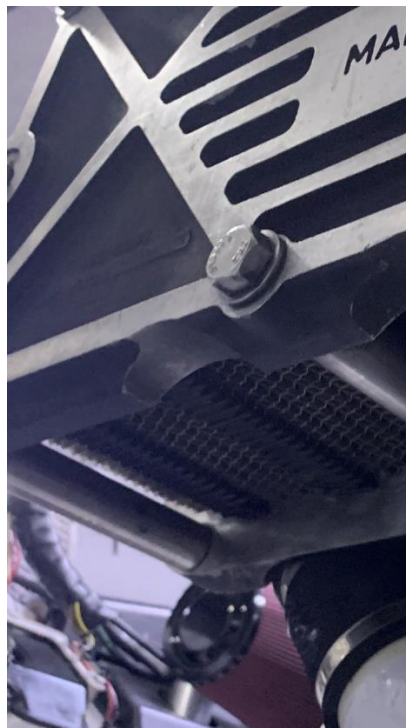
Raw water leakage not visible. (Ref. Remark 6)

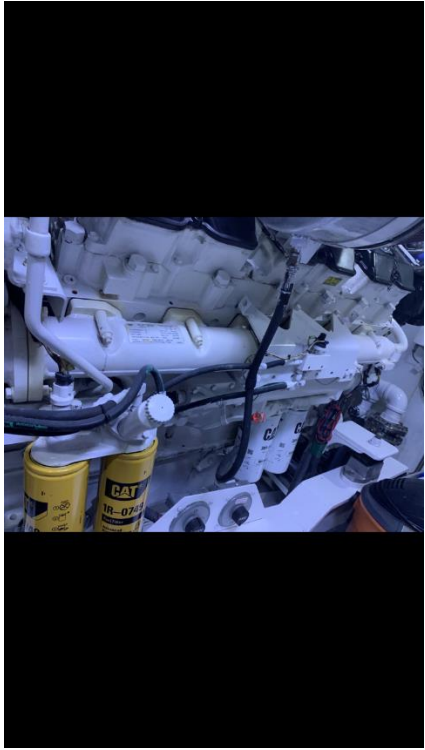
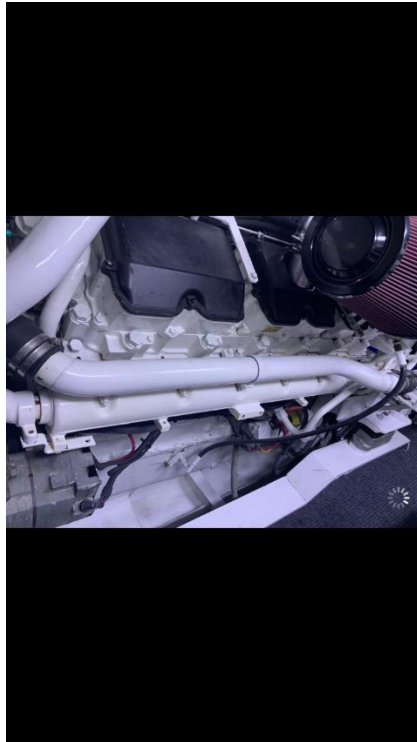
Engine pictures after sea trial and survey, show no to minimum oil leaks. Rear Main seal does show signs of minimal leak(Ref. Remark 2)

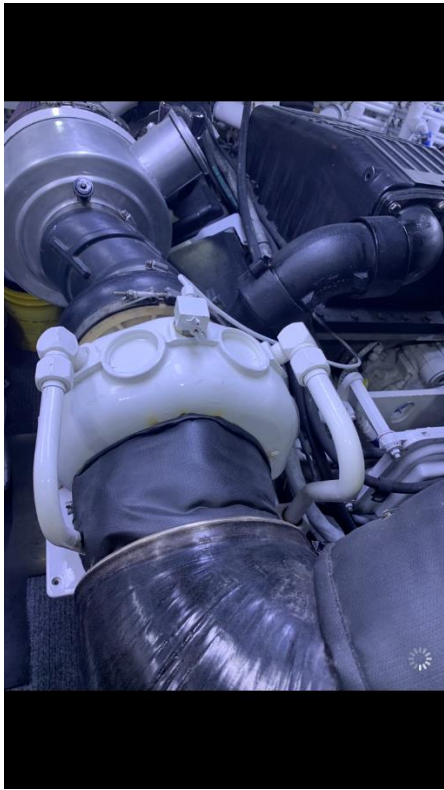
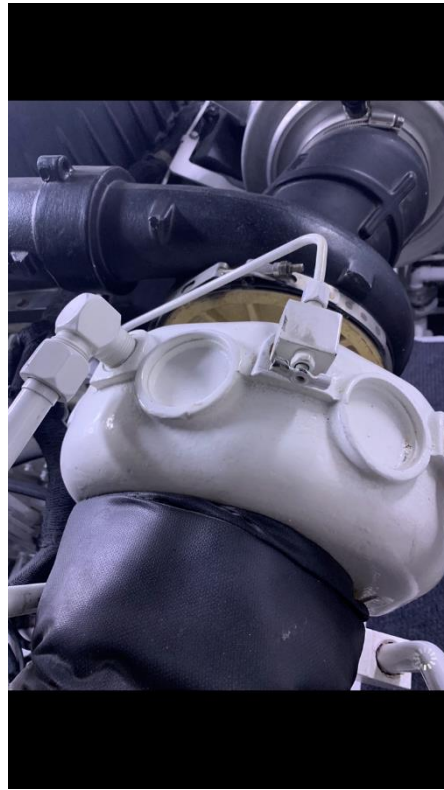
No signs of exhaust leak only minor heat discoloration. (Ref. Remark 6)

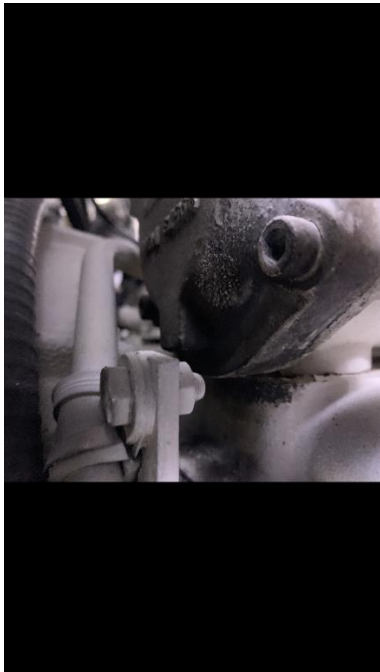
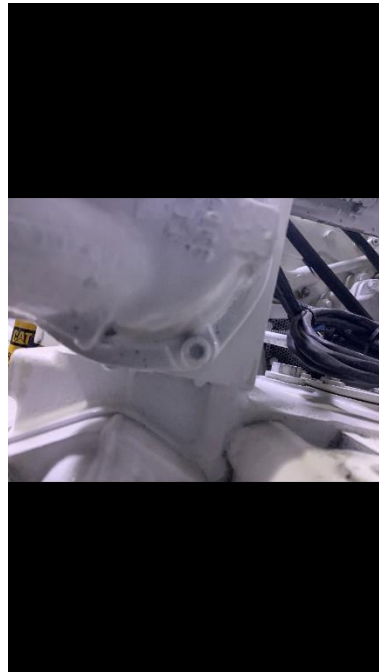
Transmission oil cooler no water leak (Ref. Remark 7)
